## Data of building to Study

## Data of the Spanish Case Study

## Technical characteristics of the building DORMITORY

### Romanian case study - School

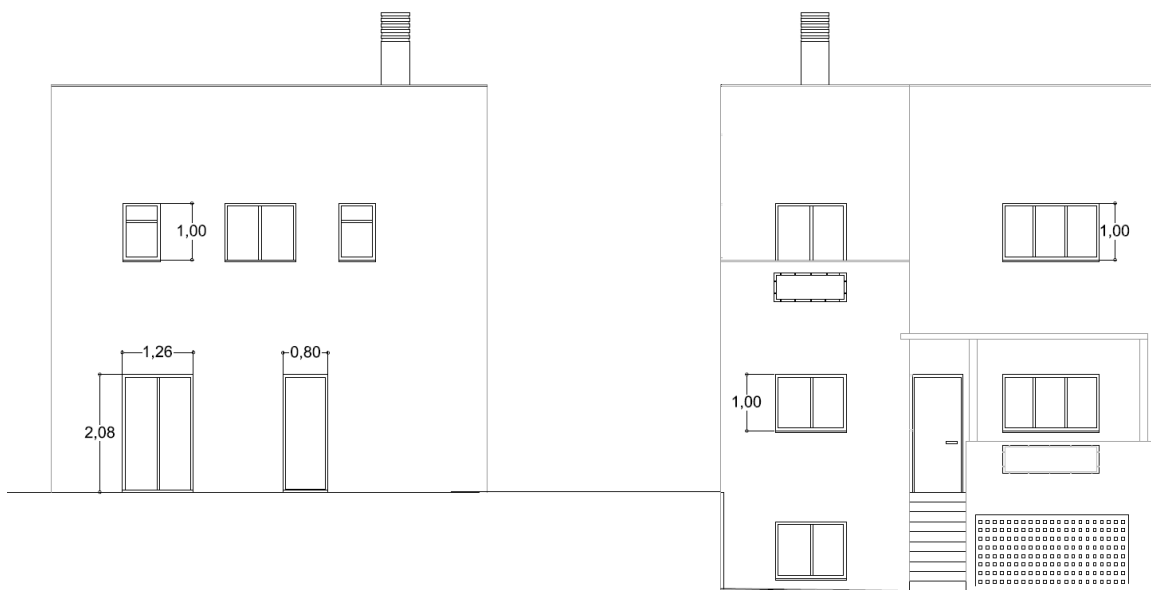
Figure 5: Rear and front elevations.

The width of the façade of this terraced house is 7.71 m and the depth is 11.64 m. On the main façade of the house has a fenced plot of 36 m<sup>2</sup> where the ramp is located to go down to the basement with the vehicle.

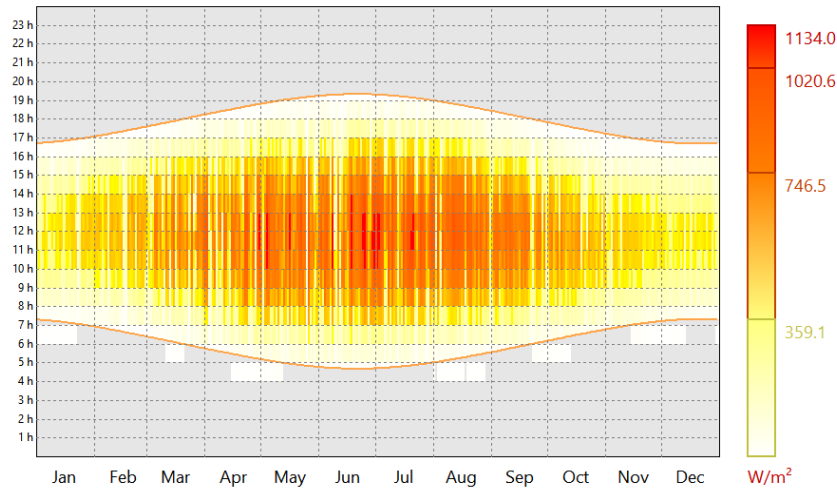
The graph below shows the global irradiance on a horizontal surface

$$Q = 73.8 + 88.9 + 130.5 + 156.7 + 194.2 + 204.3 + 219.7 + 197.9 + 150.2 + 113.8 + 79.0 + 66.0 = 1675.01 \text{ kWh/m}^2$$

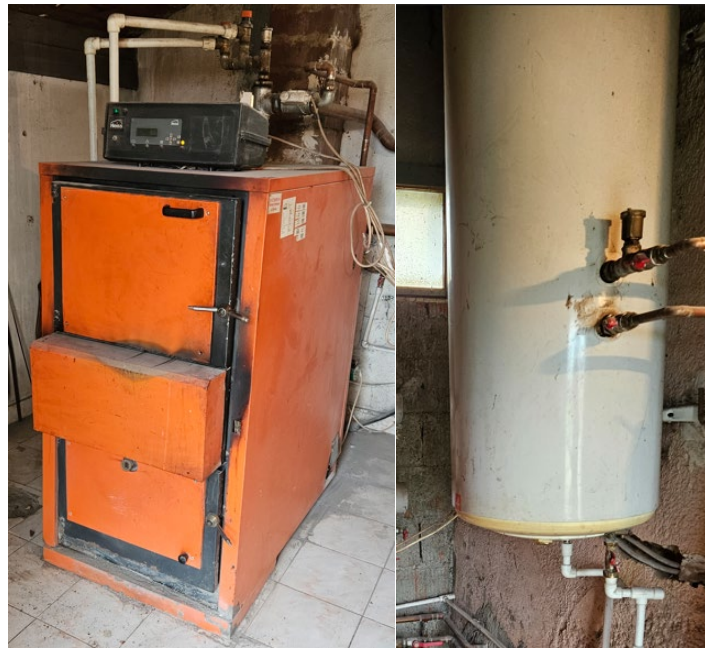
**Figure 2.** School from Romania – heating source

The heating of the building is done through steel radiators, using as heat source a solid fuel heating plant (wood) and a boiler.

The wood heating plant has low efficiency and there is no individual heat control for each radiator according to usage duration (see Fig. 2).
