Approach of case studies

1. Spanish Case Study Approach

1.1. Description of the single-family house for Spanish Case Study

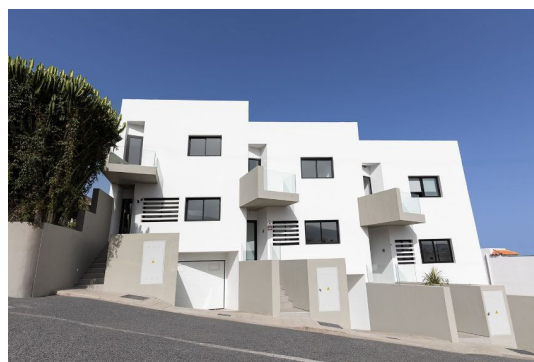
Figure 1: Terraced houses in Spain

The terraced single-family house consists of a basement, first floor and second floor. The roof of the house is a flat roof. This building was built in 2023.

The width of the façade of this terraced house is 7.71 m and the depth is 11.64 m. On the main façade of the house has a fenced plot of 36 m² where the ramp is located to go down to the basement with the vehicle.

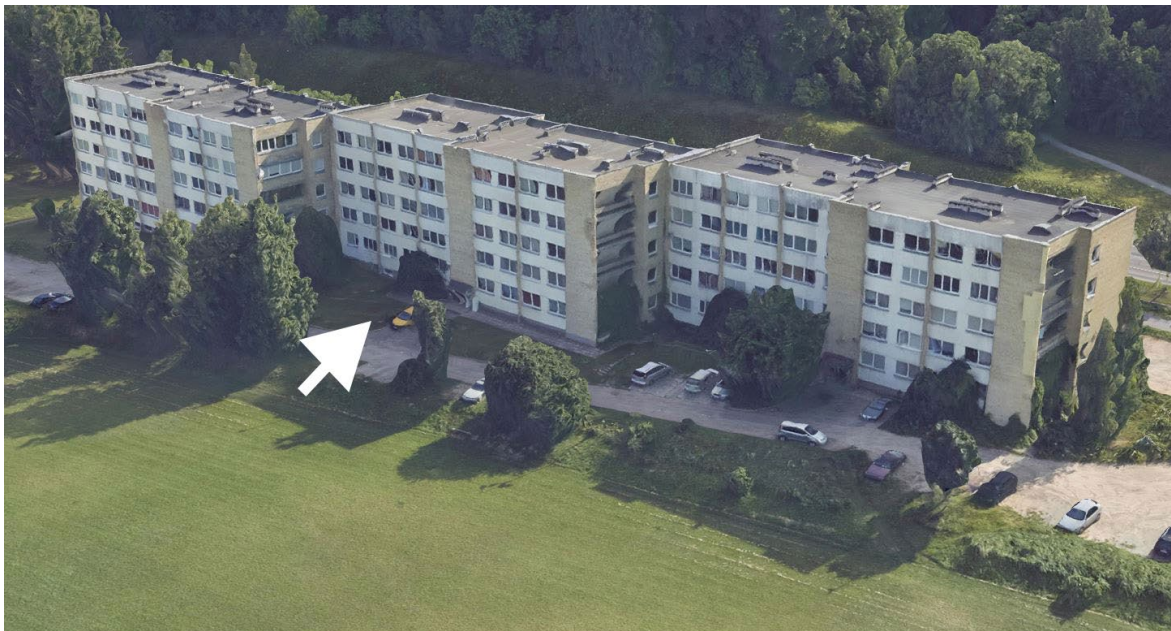
Figure 2: Dormitory building in Vilnius

It is a 5-storey building for residential use. Main entrance (front facade) of the dormitory is located on the East side of the building, facing Stanevičiaus Street.

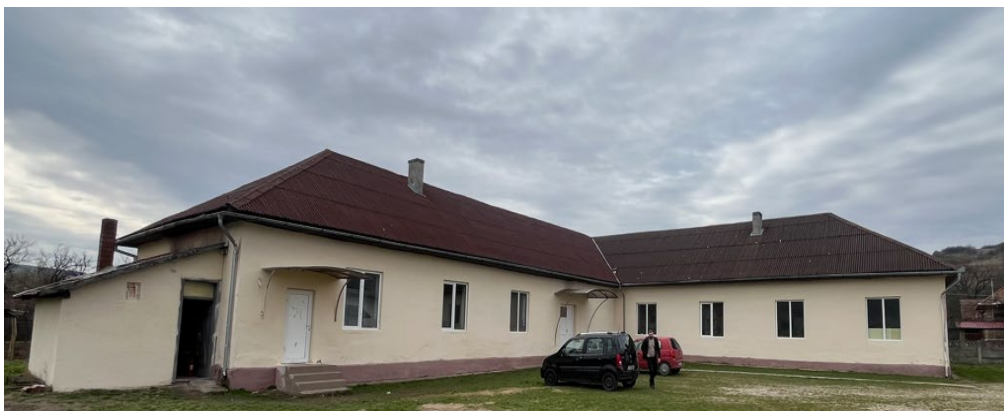
Figure 3: School Building in Romania

The building has one ground floor and a total built area of 512 square metres, with a total useful area of 413.8 square metres. It comprises 3 classrooms, 1 kindergarten room, two hallways, a teaching materials storage, an office, three storage rooms, a toilet and a technical room.

The building has a structure consisting of continuous foundations made of stone and concrete, walls made of solid brick or stone masonry, attic floor made of wooden beams and a wooden roof with covering made of bituminous corrugated boards. The interior walls were finished with washable paint or tiles, while the exterior was enhanced with decorative plastering. Concrete floors are covered with parquet or tiles. The building is not insulated. The windows are PVC with double glazing.

The cold water supply is derived from the local network. The building is heated by a solid fuel thermal plant and a boiler, which are connected to steel radiators. The lighting system is comprised primarily of neon fluorescent tubes. The building lacks a ventilation or air conditioning system
